ASBESTOS-CONTAINING BUILDING MATERIALS INSPECTION

**200 Ash Street
BLOCK 1405, LOT 6
DELANCO, NEW JERSEY**

August 3, 2020

Prepared by:
**Harry R. Fox, Asbestos Management Planner & Project Designer
Environmental Resolutions, Inc.
815 East Gate Drive Road, Suite 103
Mount Laurel, New Jersey 08054**

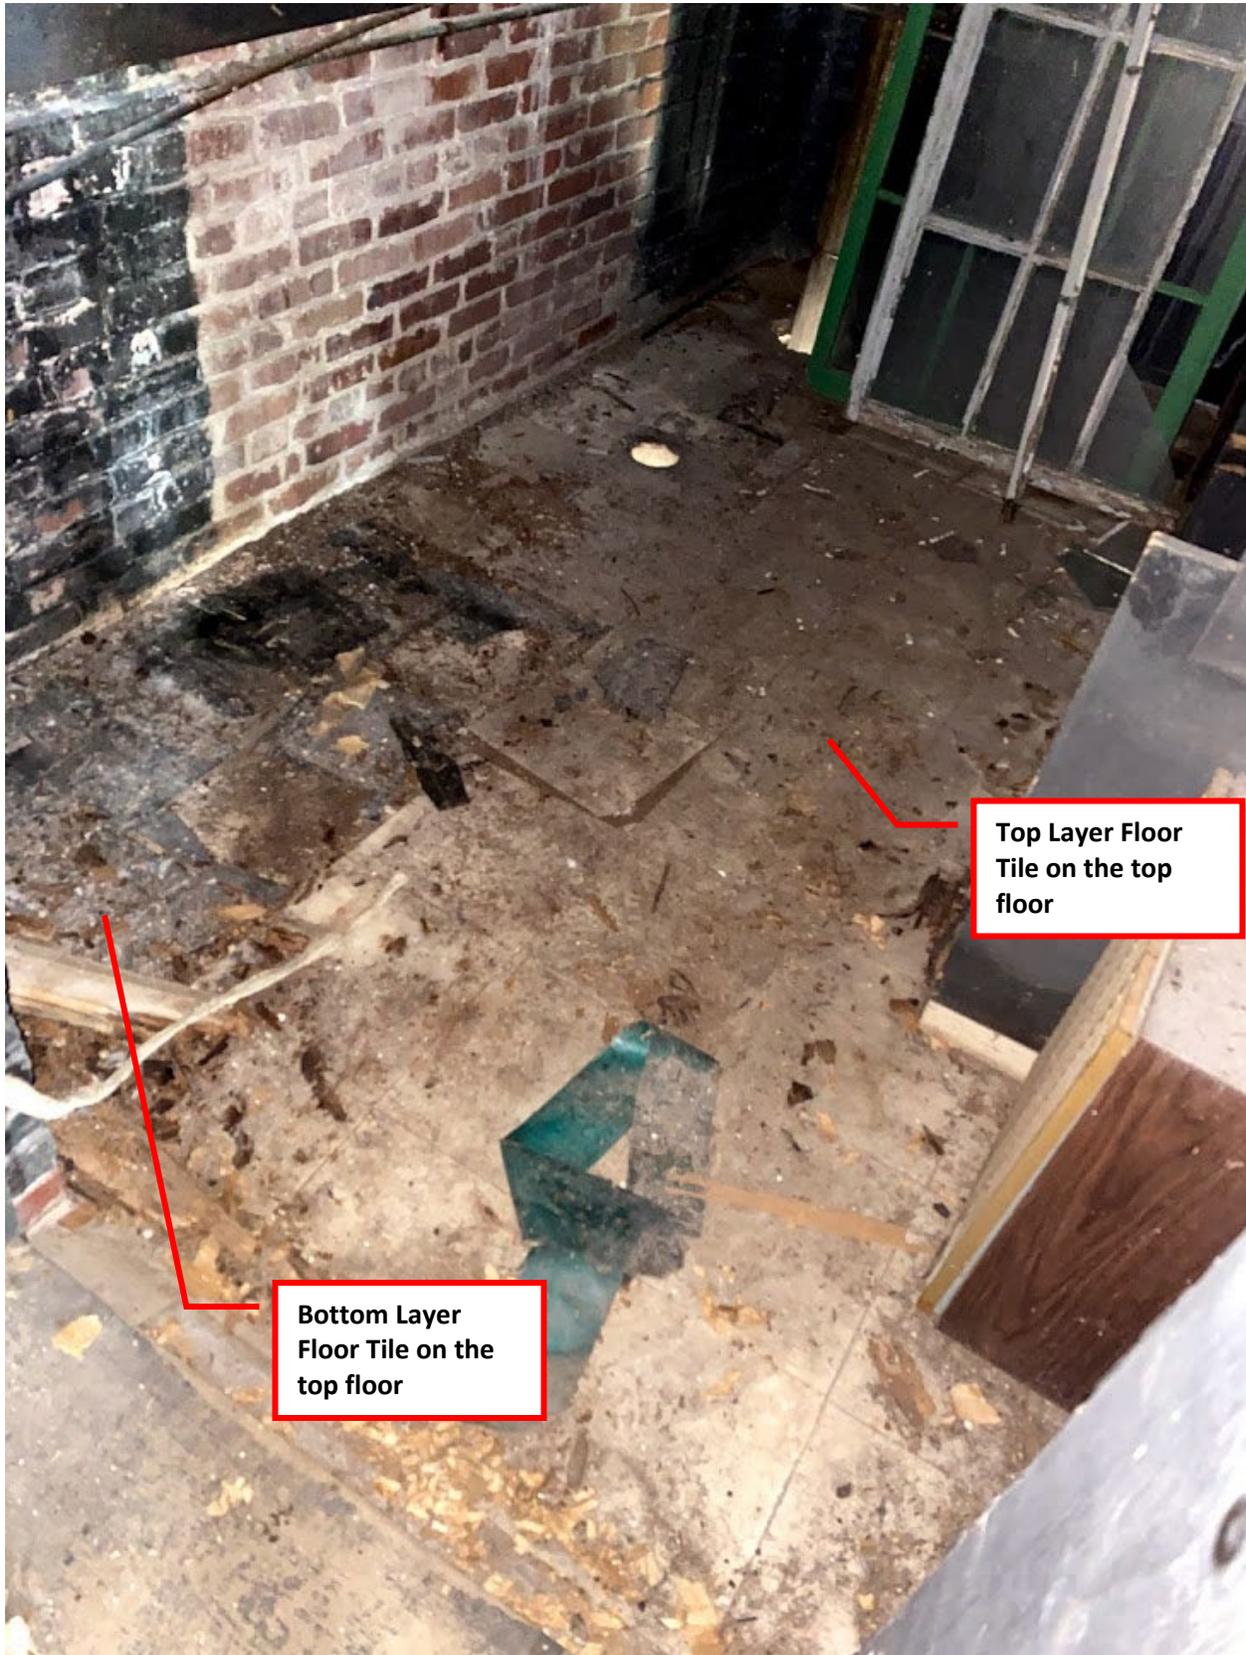
Approximately 80 square feet of 9x9 vinyl floor tile contains asbestos and must be abated. The floor tile is in the Western room on the top floor of the building. There are 2 layers of floor tiles, both ACM, and this is the top layer of tiles. All work in this area shall be achieved by the "Heat Method", in accordance with the "Resilient Floor Covering Institute" recommended work practices for removal of resilient floor coverings, in full isolation containment with negative air pressure differential and three stage personnel decontamination units.

Approximately 80 square feet of 9x9 vinyl floor tile contains asbestos and must be abated. The floor tile is in the Western room on the top floor of the building. There are 2 layers of floor tiles, both ACM, and this is the bottom layer of tiles. All work in this area shall be achieved by the "Heat Method", in accordance with the "Resilient Floor Covering Institute" recommended work practices for removal of resilient floor coverings, in full isolation containment with negative air pressure differential and three stage personnel decontamination units.

Figure 1: ACM Floor Tiles in the Western room on the top floor

B. Floor Tile, Top Floor:

C. Floor Tile, Top Floor:

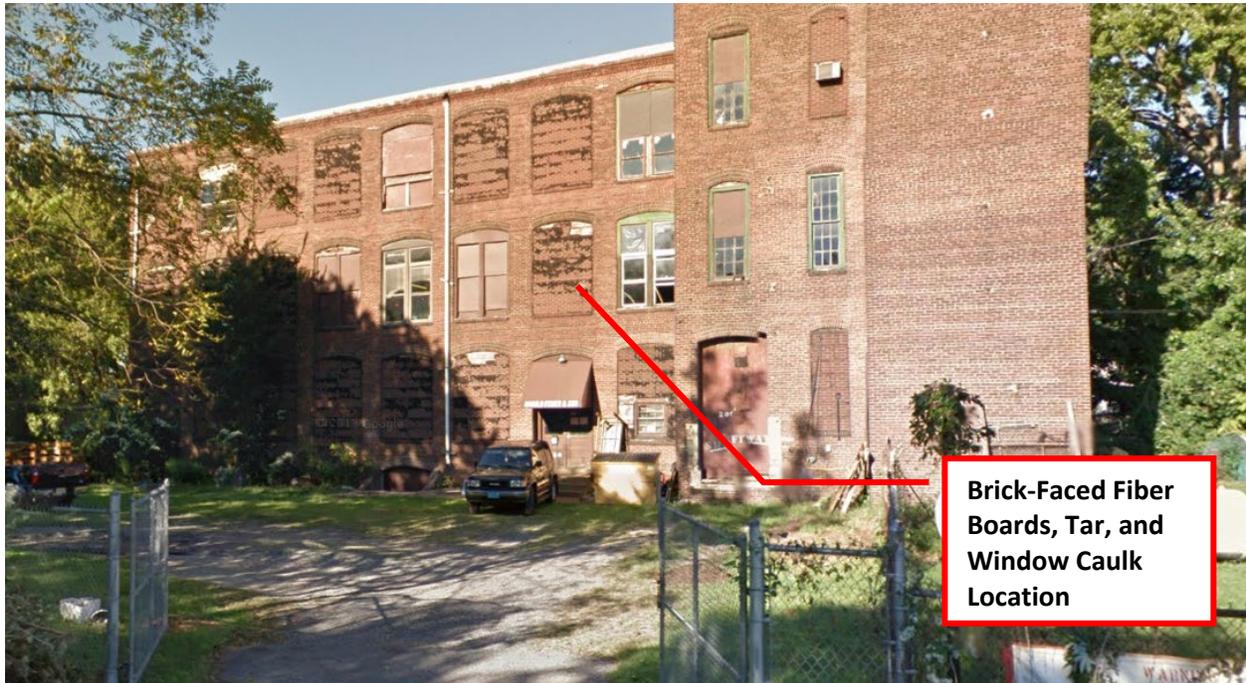
Covering some of the exterior windows contain 3% Chrysotile and should be removed via the Wet Method. There are approximately 1,200 square feet of this fiber board covering about 20 windows around the building. Remove and properly discard of all the fiber boards. Safe work practices and all applicable regulations shall be employed to minimize asbestos fiber exposure during the tear-off period.

ACM Caulk is used on the windows that contain the fiber board, and not the remaining windows. The caulk should be removed at the same time as the fiber boards using the Wet Method. There is approximately 600 LF of window caulking.

Figure 2: Exterior view of the Brick-Faced Fiber Board

A. Exterior Brick Fiber Board:

A. Caulk on Exterior Windows:

Remove and properly discard all Caulking Material. Safe work practices shall be employed to minimize asbestos fiber exposure during the tear-off period.

There is approximately 1,200 square feet of tar on the fiber boards that must be removed along with the Brick Fiber Board and Window Caulk. The Wet Method should be applied to the tar so it is properly wet. Remove and properly discard all this material. Safe work practices shall be employed to minimize asbestos fiber exposure during the tear-off period.

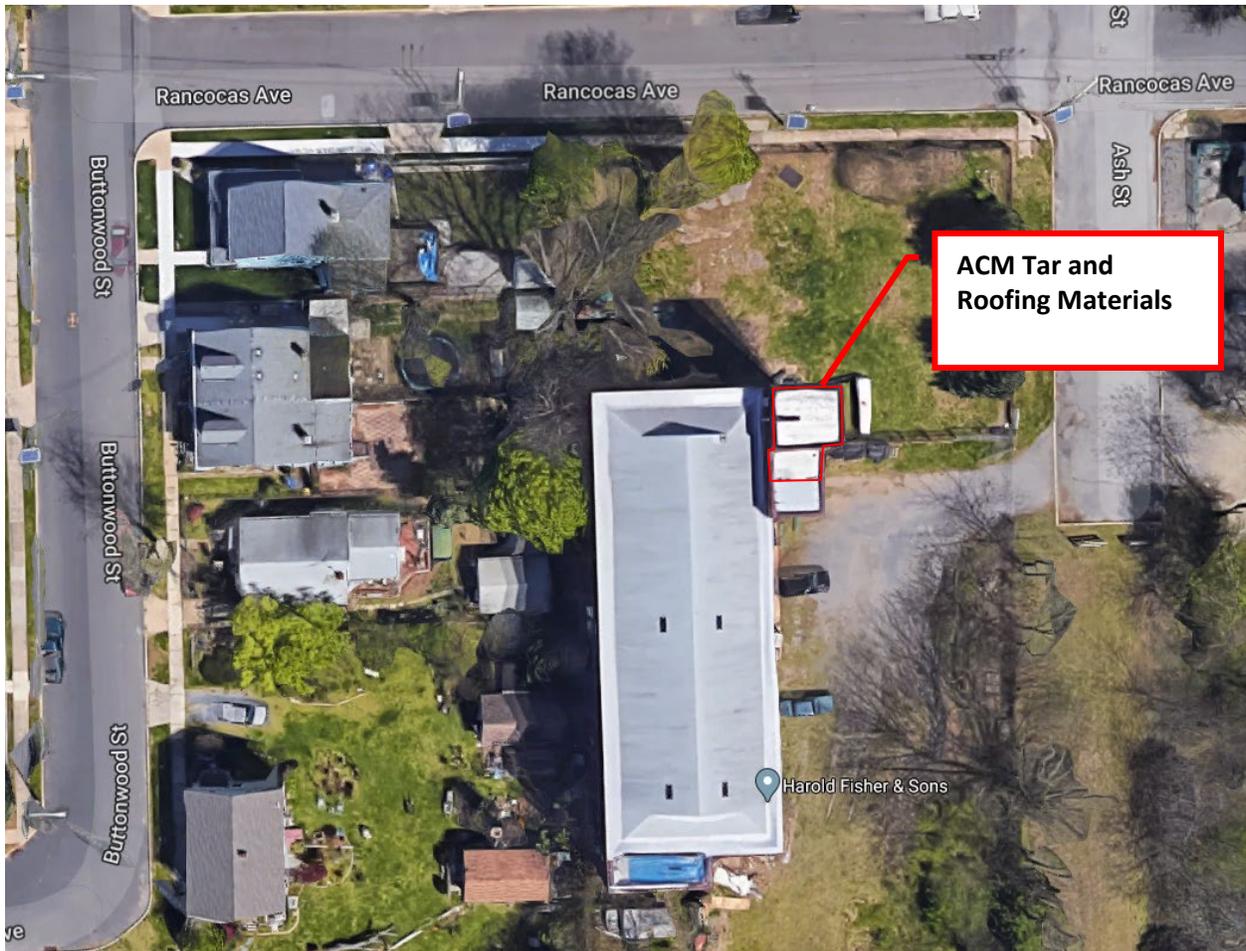
Environmental Resolutions identified eight (8) building materials suspected to contain asbestos, which includes 3 different floor tiles, window frame caulk, roofing flashing & tar adhesive, and fiber board & tar adhesive on the exterior windows. In addition there are roofing materials (Attachment A, Figure 3) that could not be safely accessed during the investigation that should be considered assumed ACM unless further testing proves otherwise.

There is asbestos in the roofing and associated materials above the stairwell in the N-E corner of the building. There is approximately 1,130 square feet of roofing material in this location. All the specified roofing materials shall be removed and properly discarded using safe work practices to minimize asbestos fiber exposure during the tear-off period.

Remove and properly discard of 100 square feet of Roofing Tar located above the stairwell in the Northeastern corner of the building, and a few small piles near the top of the stairwell. Some of this roofing has fallen and created piles of ACM at the top of the stairwell. All work in this area shall be accomplished by Wet Method. All the tar shall be removed and properly discarded using safe work practices to minimize asbestos fiber exposure during the tear-off period.

Figure 2: Aerial view depicting where the Roofing ACM is Located

C. Roofing Materials:

D. Roof Tar:
