SITE INVESTIGATION REPORT

**200 ASH STREET
BLOCK 1405, LOT 6
DELANCO TOWNSHIP
BURLINGTON COUNTY, NEW JERSEY**

Township of Delanco
770 Coopertown Road
Delanco, NJ 08075

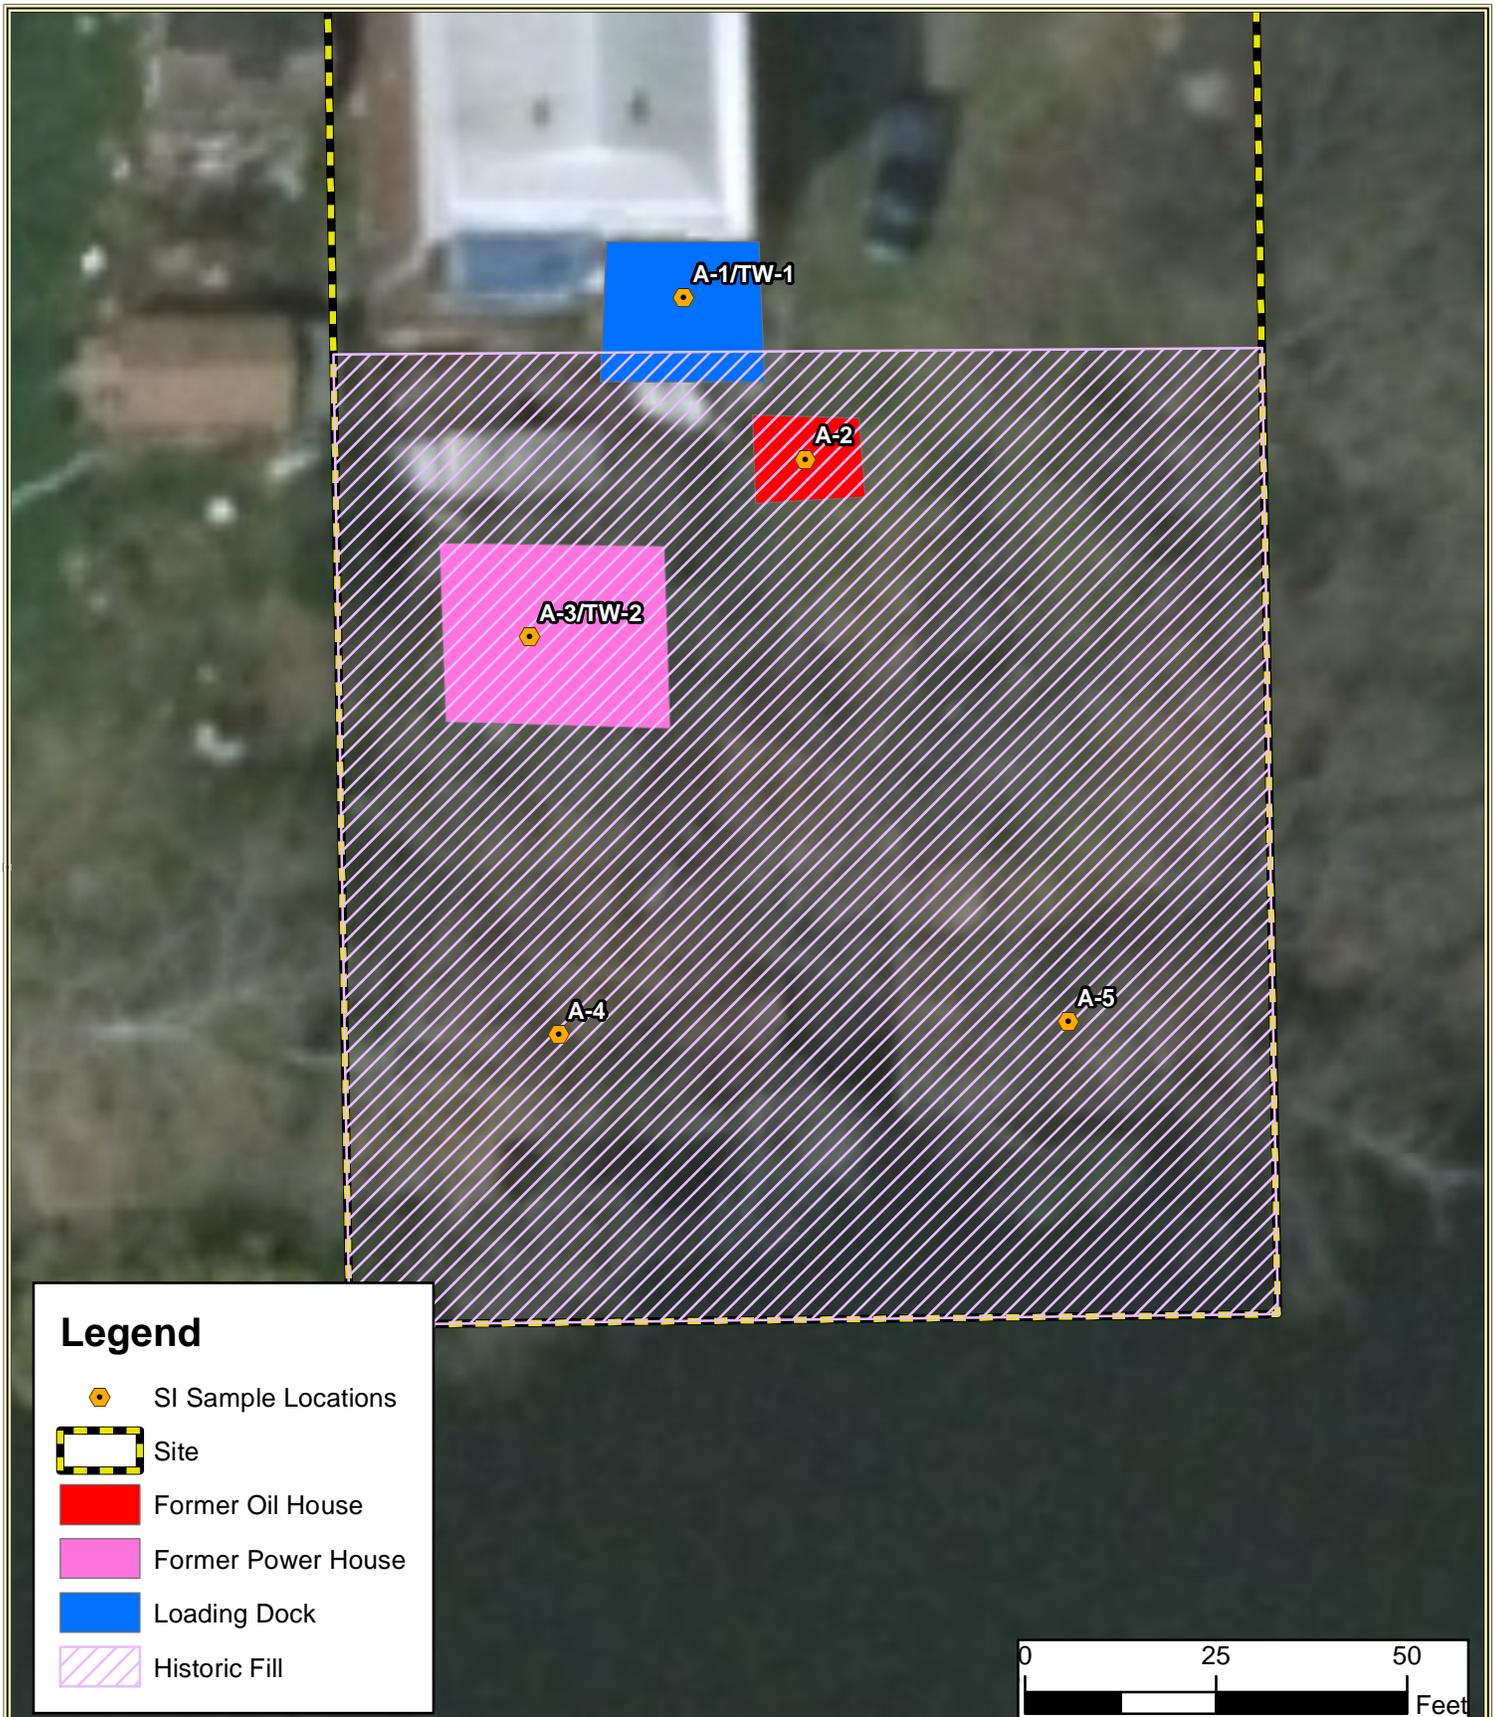
FIGURE 3: SITE INVESTIGATION MAP

The Site Investigation was conducted to assess AOCs 1 through 5. Samples were collected by advancing soil borings using a direct-push sampling unit. The direct-push sampler utilized a 1-3/4" outer diameter polyethylene insert to obtain five-foot long continuous soil samples. A photoionization detector (PID) was used to screen the soil for volatile vapors. Subsurface conditions are depicted on the Boring Logs included in **Appendix A**. The boring locations are shown on **Figure 3: Site Investigation Map**.

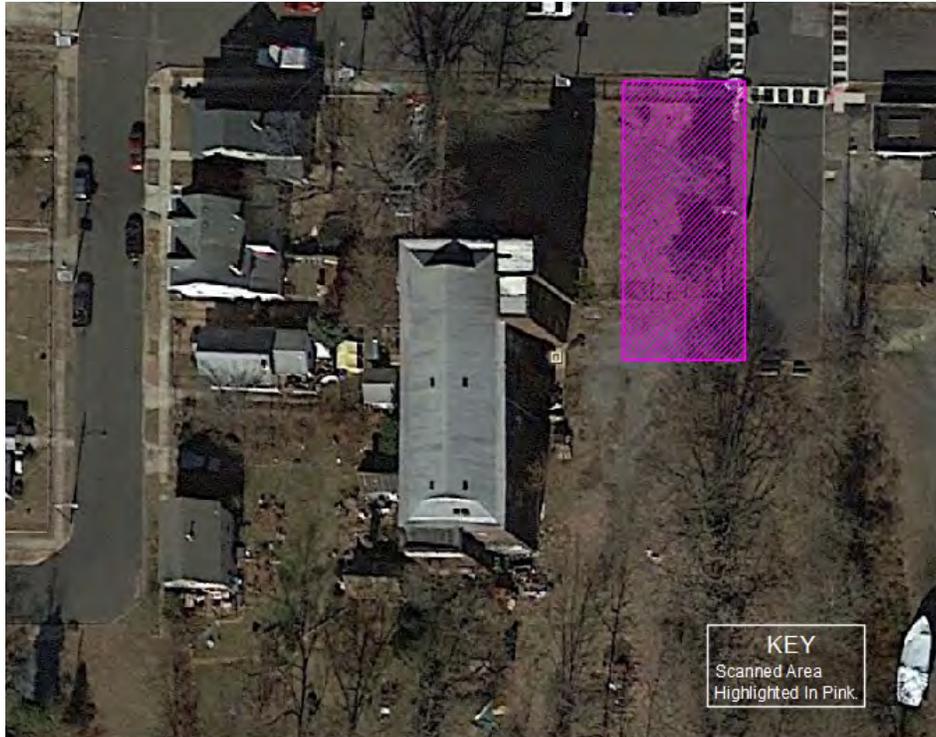
The GPR and TW-6 were used in a grid pattern over all client specified areas of the site. Based on the results of the GPR and TW-6 surveys, no metallic anomalies which typically consist with a UST, vent piping, or product piping were detected on site.
